Waterhen Area (73K)  
CROSS SECTION  
L-L'

Accompanies SRC report R-1510-6-E-97  
Drawing name: 73k\_L.dwg  
Date: July 1997

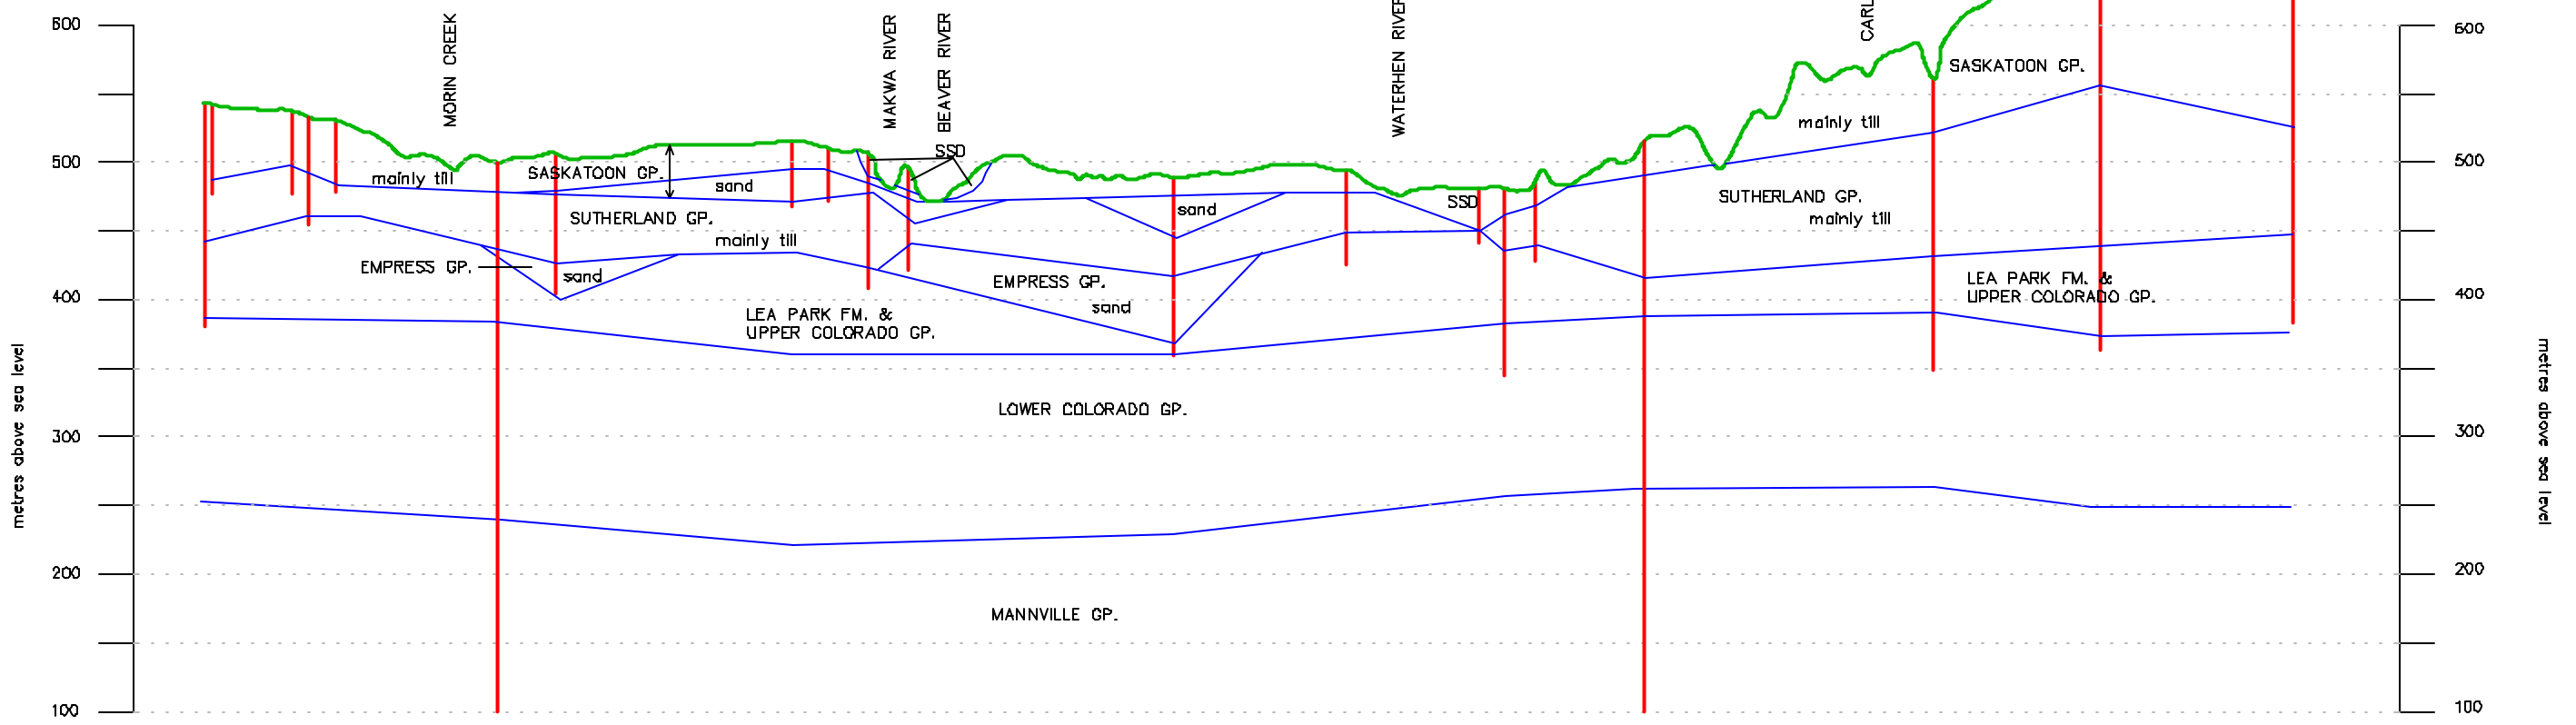
LIMITATIONS:  
Except at testhole sites where geological logs are available the geologic contacts are inferred and represent geologic models that are believed to best fit the information.
