Appendix D: Hydrographs of 1984 Pumping Test

Hydrographs of 1984 pumping test

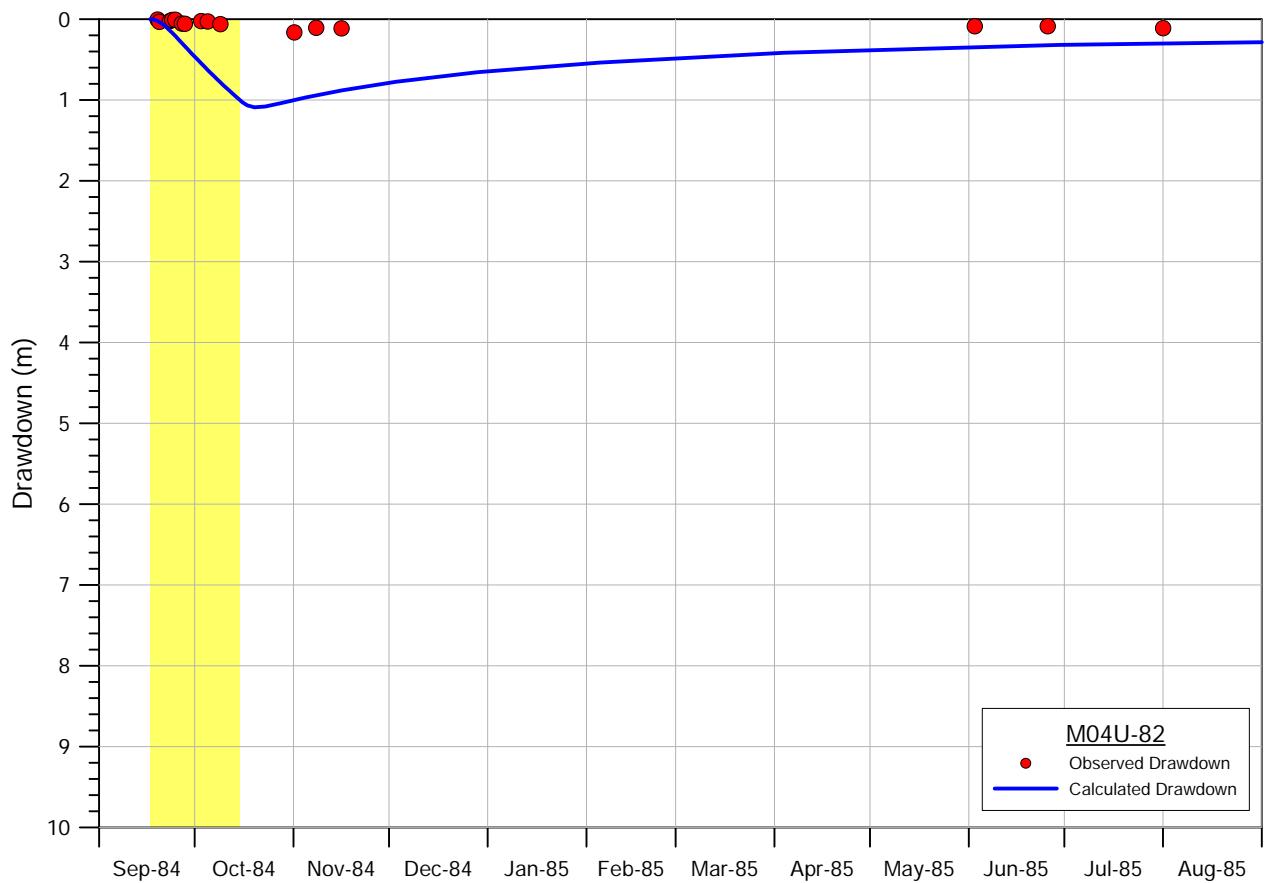
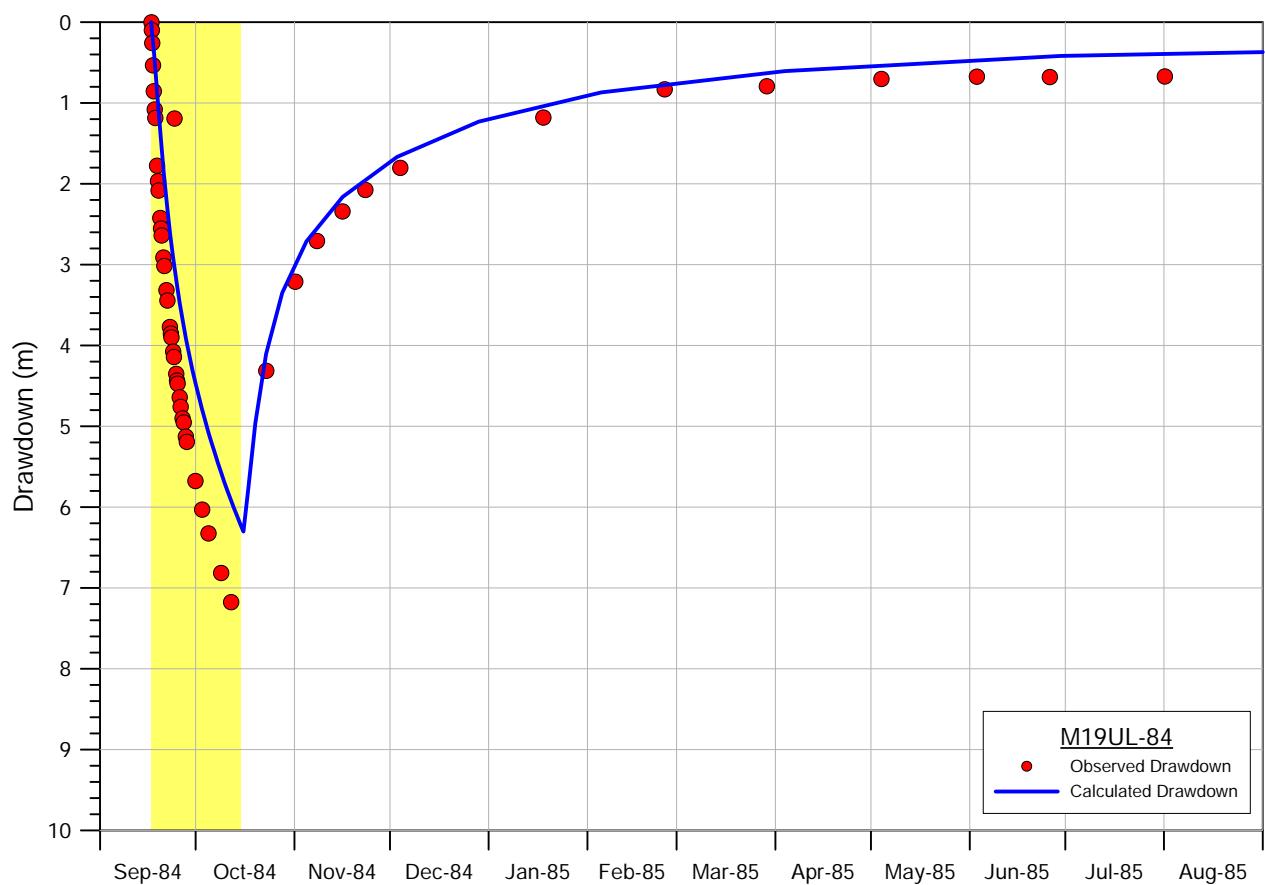
Figure D.1: Drawdown in wells **M04U-82** and **M19UL-84** during 1984 pumping test

Figure D.1: Drawdown in wells M04U-82 and M19UL-84 during 1984 pumping test

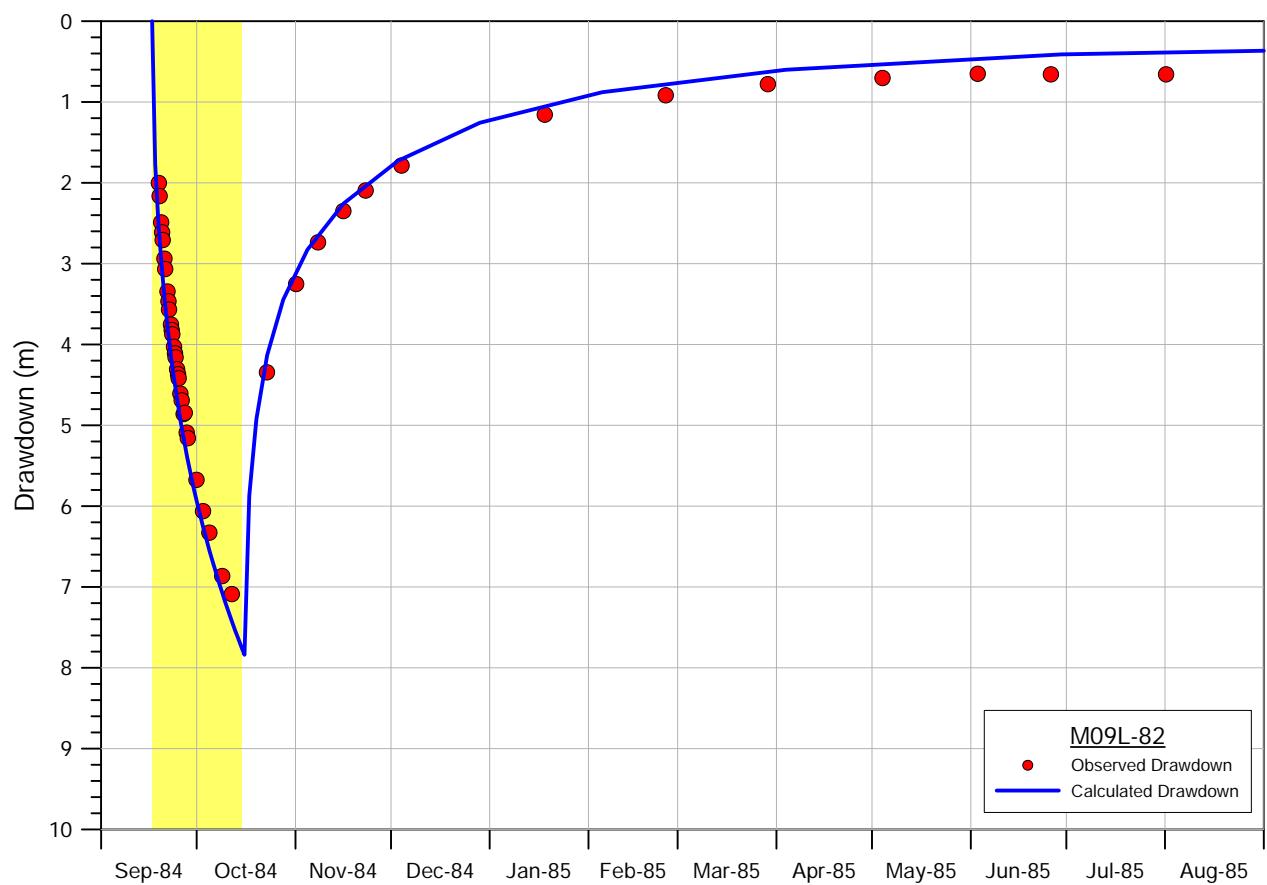
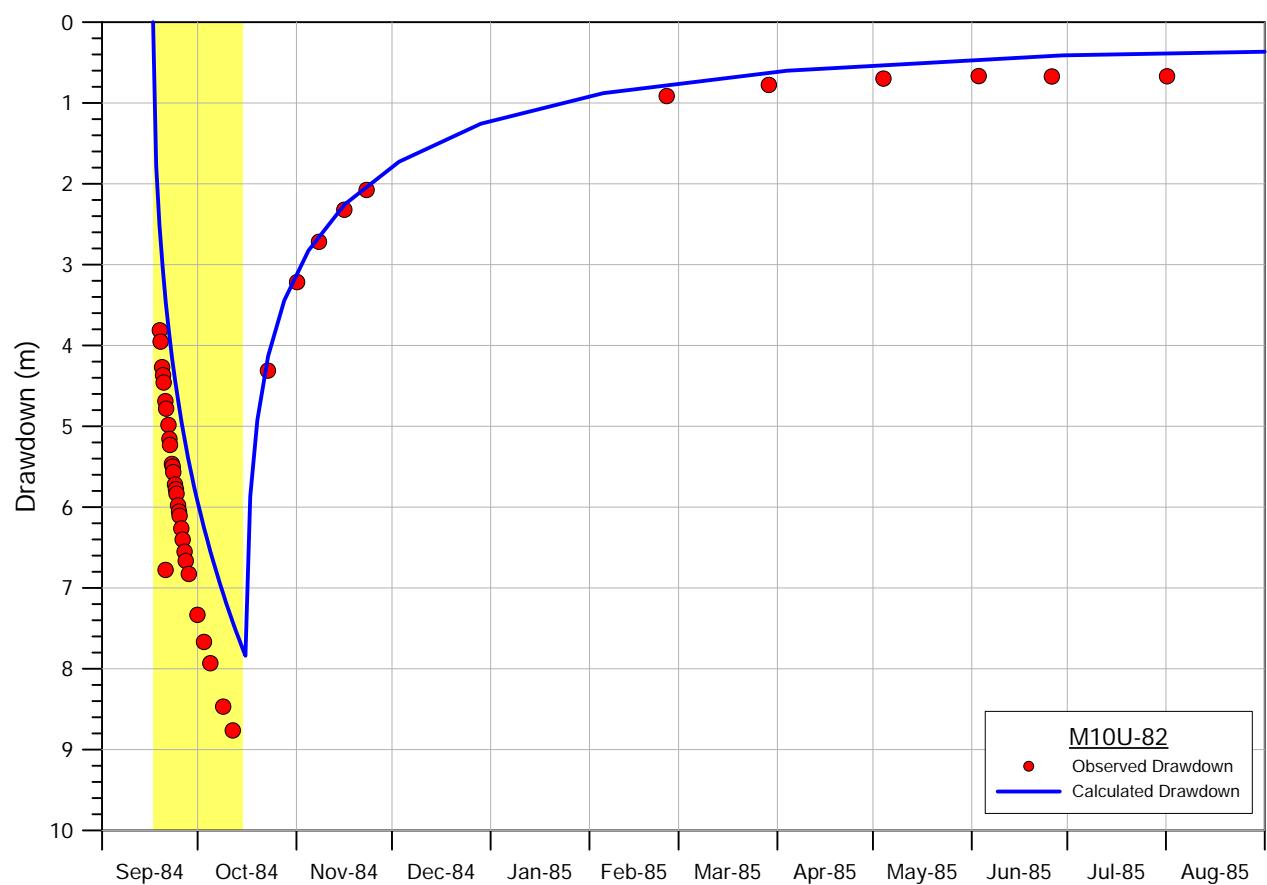
Figure D.2: Drawdown in wells **M09L-82** and **M10U-82** during 1984 pumping test

Figure D.2: Drawdown in wells M09L-82 and M10U-82 during 1984 pumping test

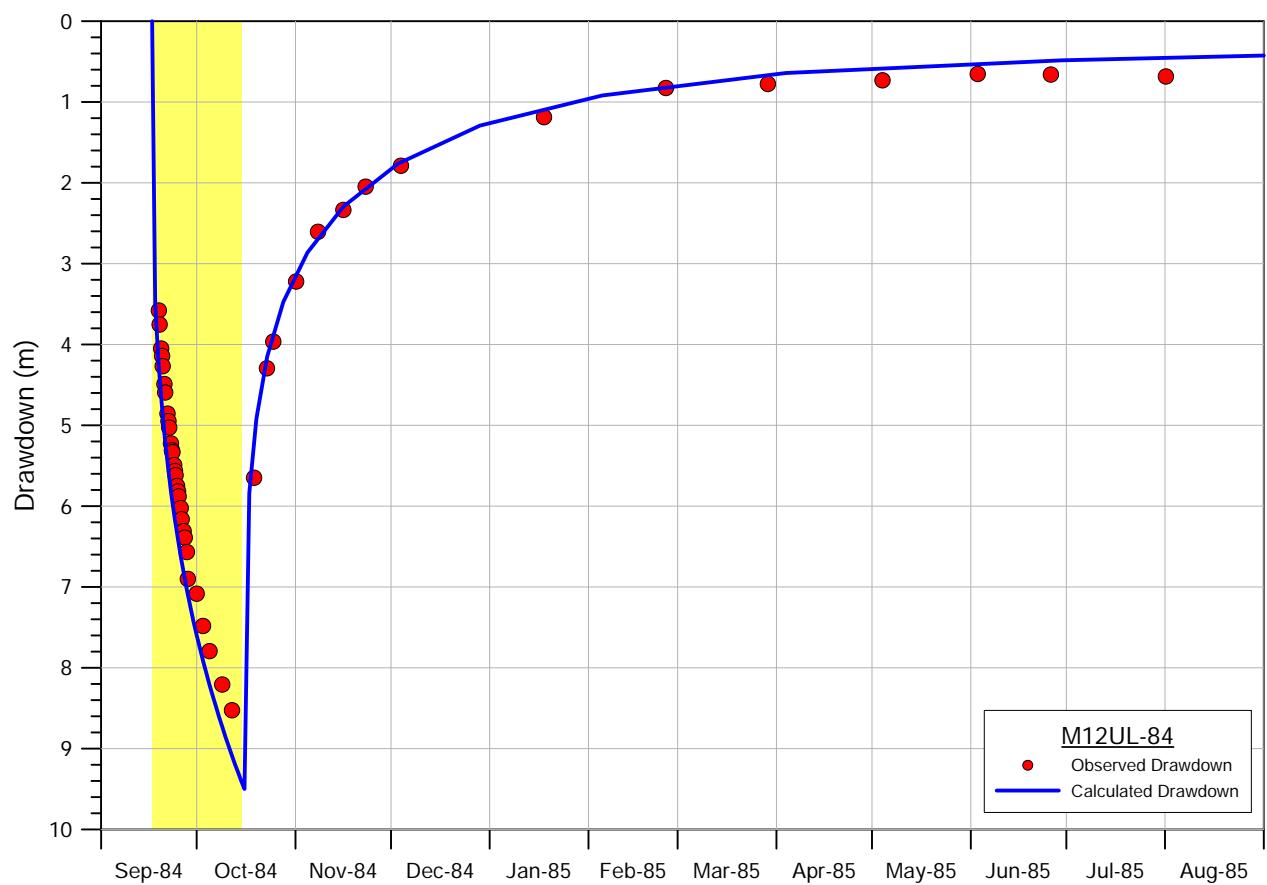
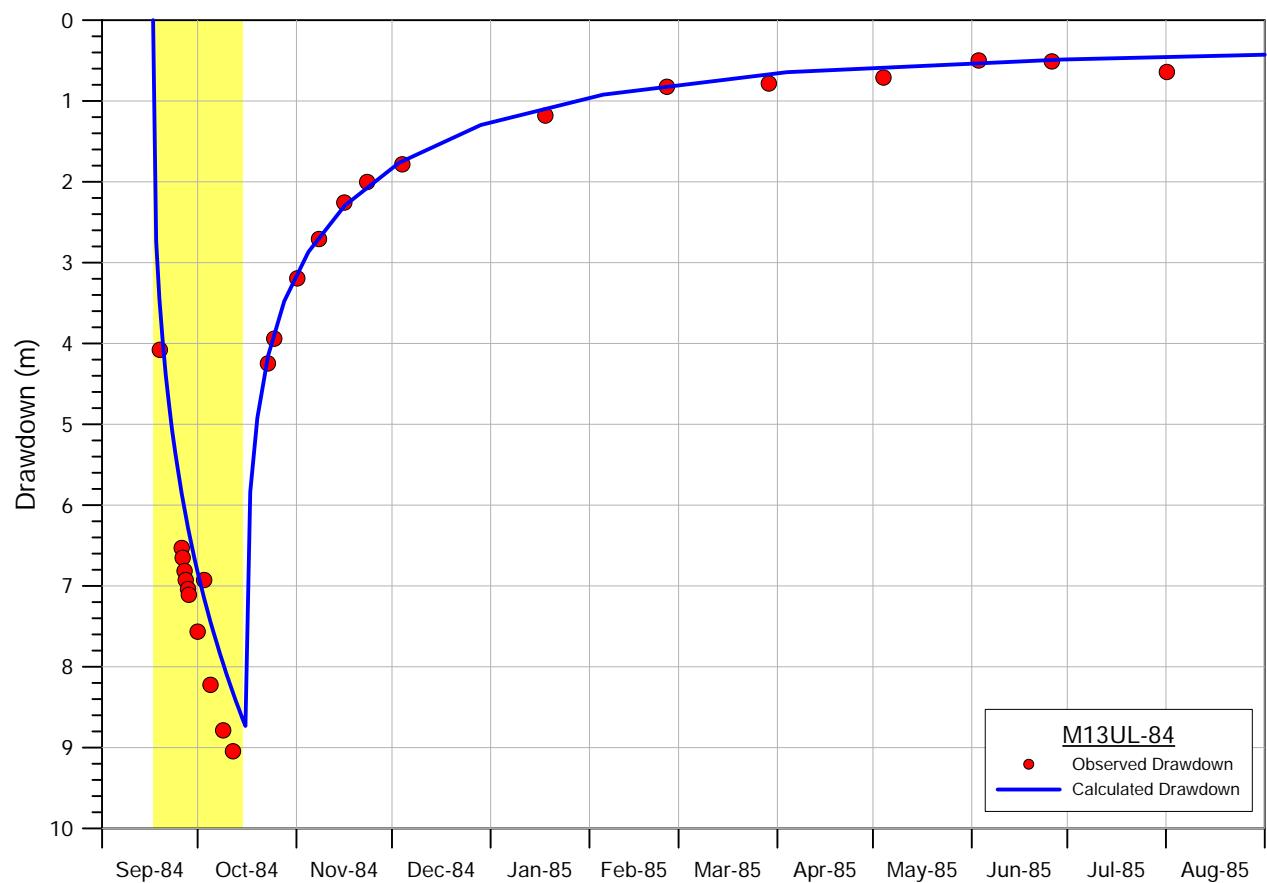
Figure D.3: Drawdown in wells **M12UL-84** and **M13UL-84** during 1984 pumping test

Figure D.3: Drawdown in wells M12UL-84 and M13UL-84 during 1984 pumping test

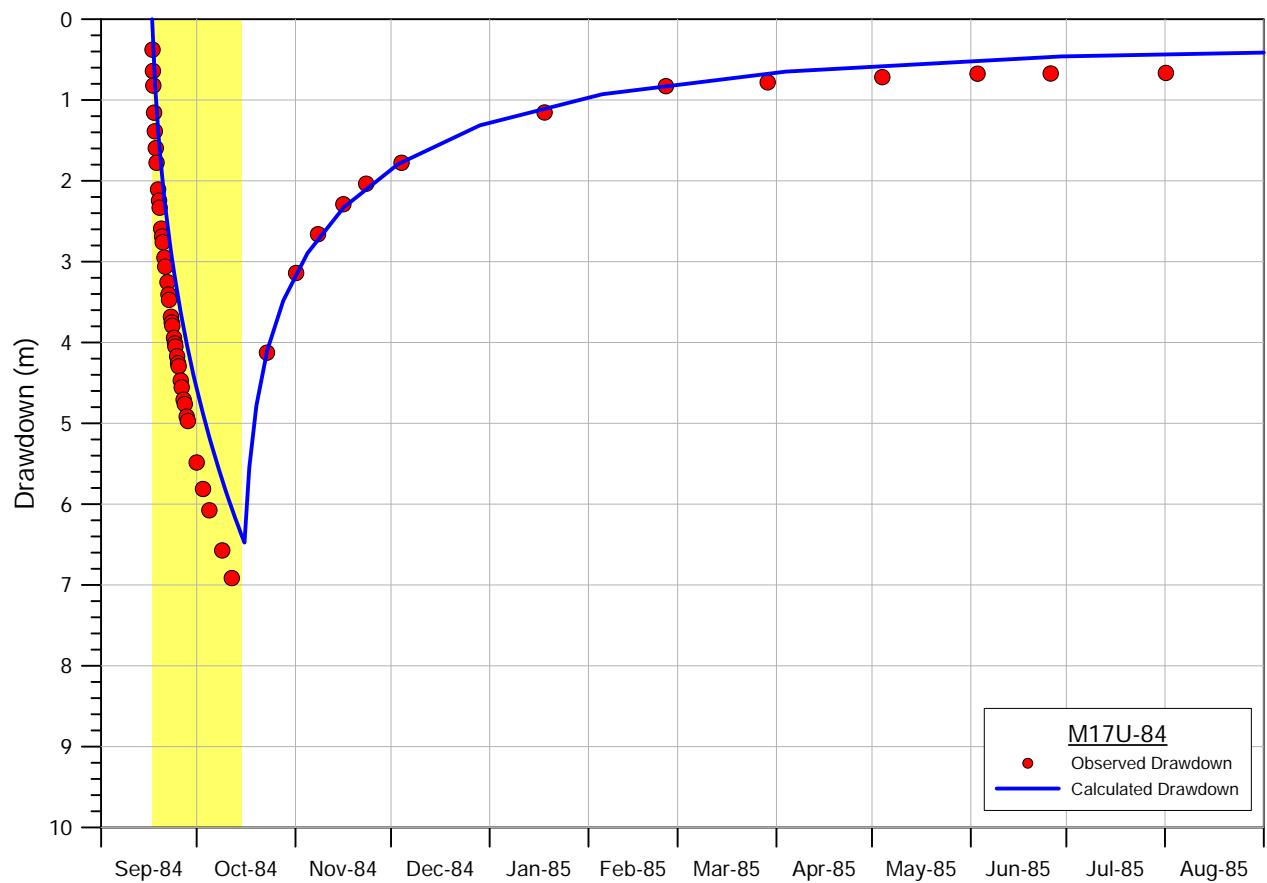
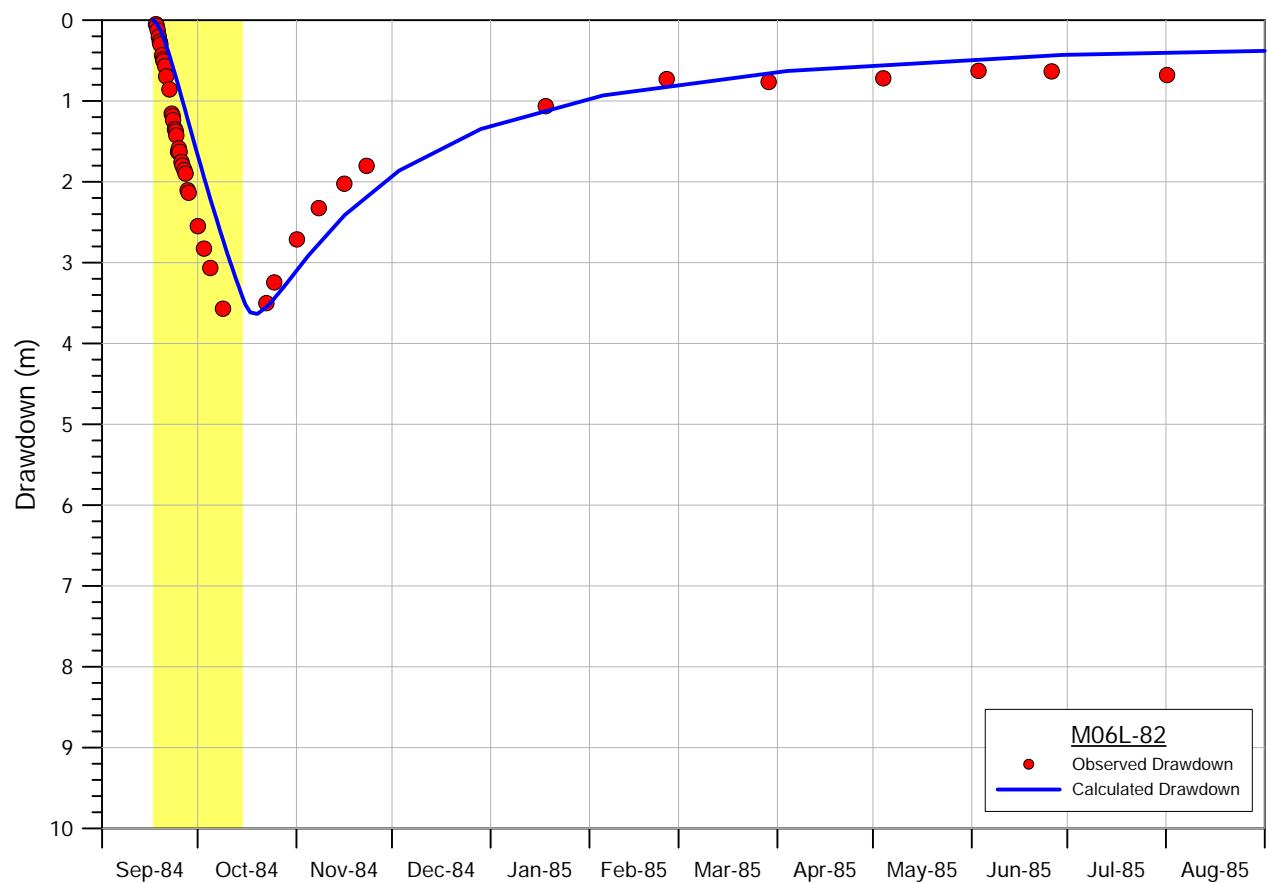
Figure D.4: Drawdown in wells **M17U-84** and **M06L-82** during 1984 pumping test

Figure D.4: Drawdown in wells M17U-84 and M06L-82 during 1984 pumping test

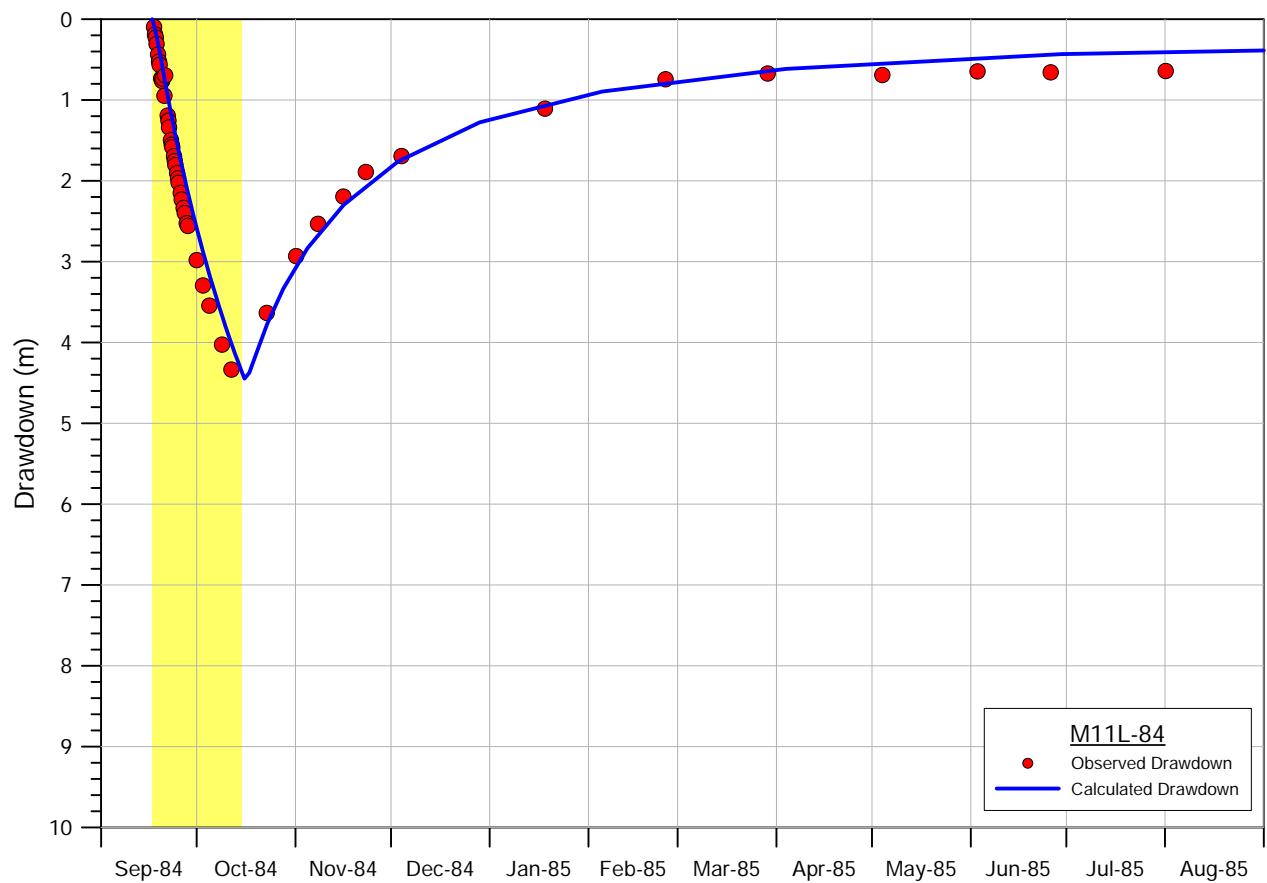
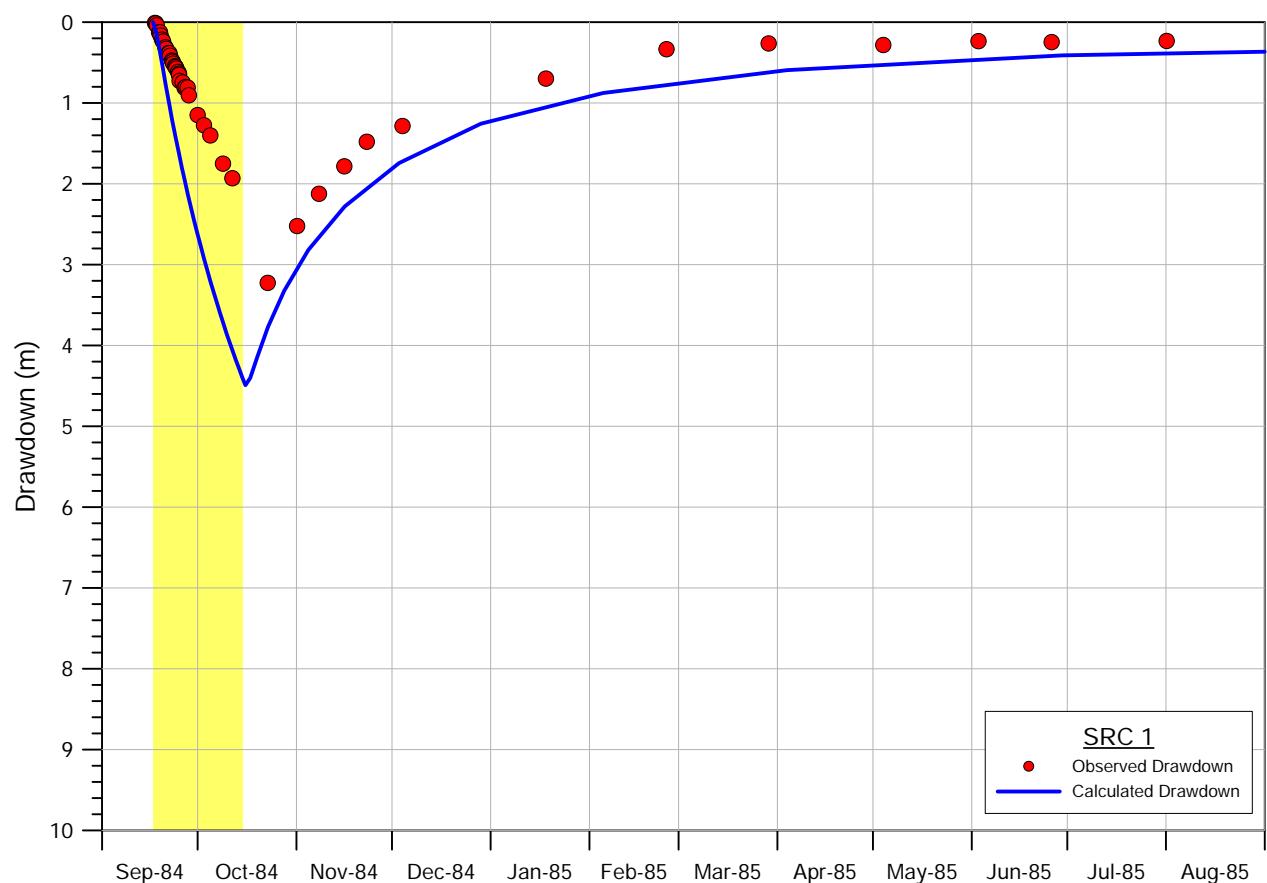
Figure D.5: Drawdown in wells **M11L-84** and **SRC 1** during 1984 pumping test

Figure D.5: Drawdown in wells M11L-84 and SRC 1 during 1984 pumping test

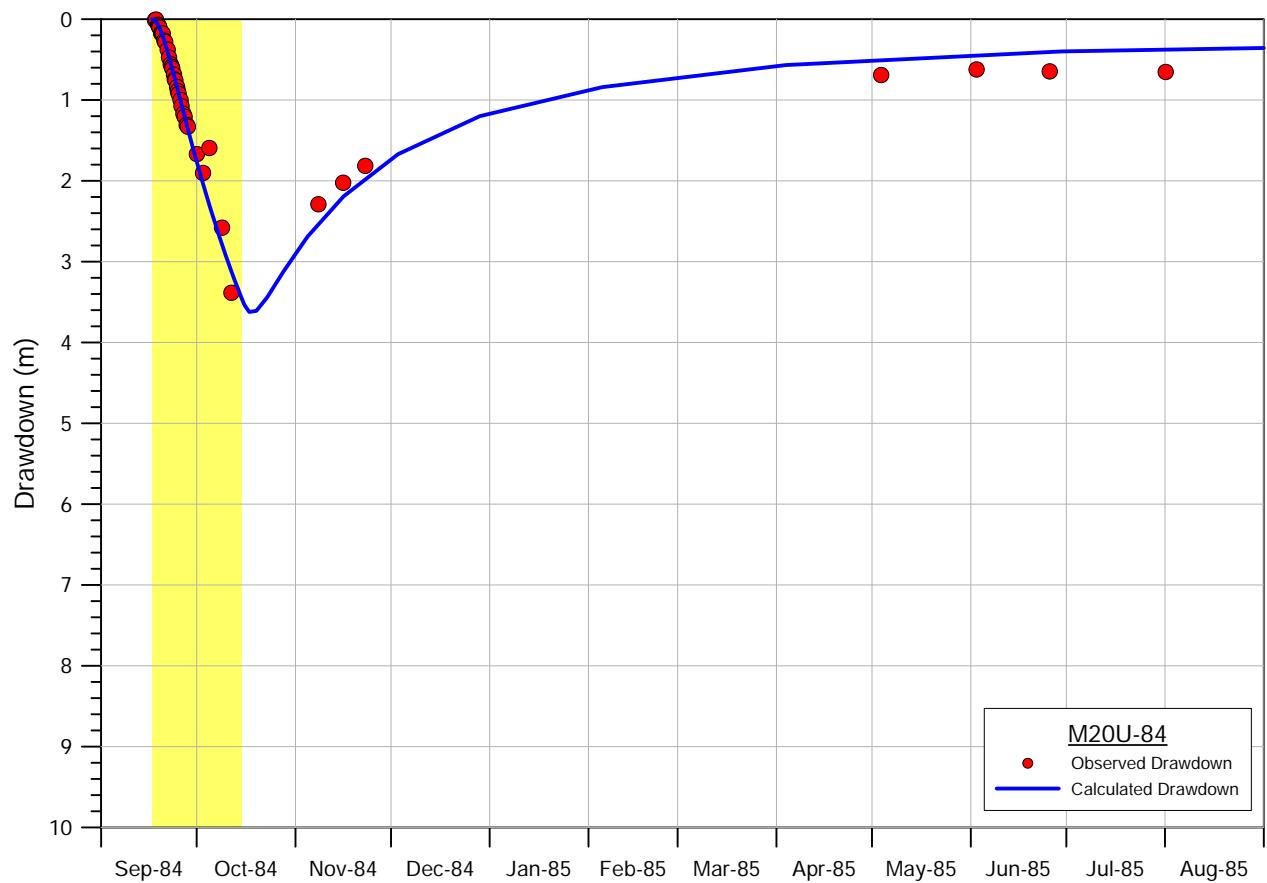
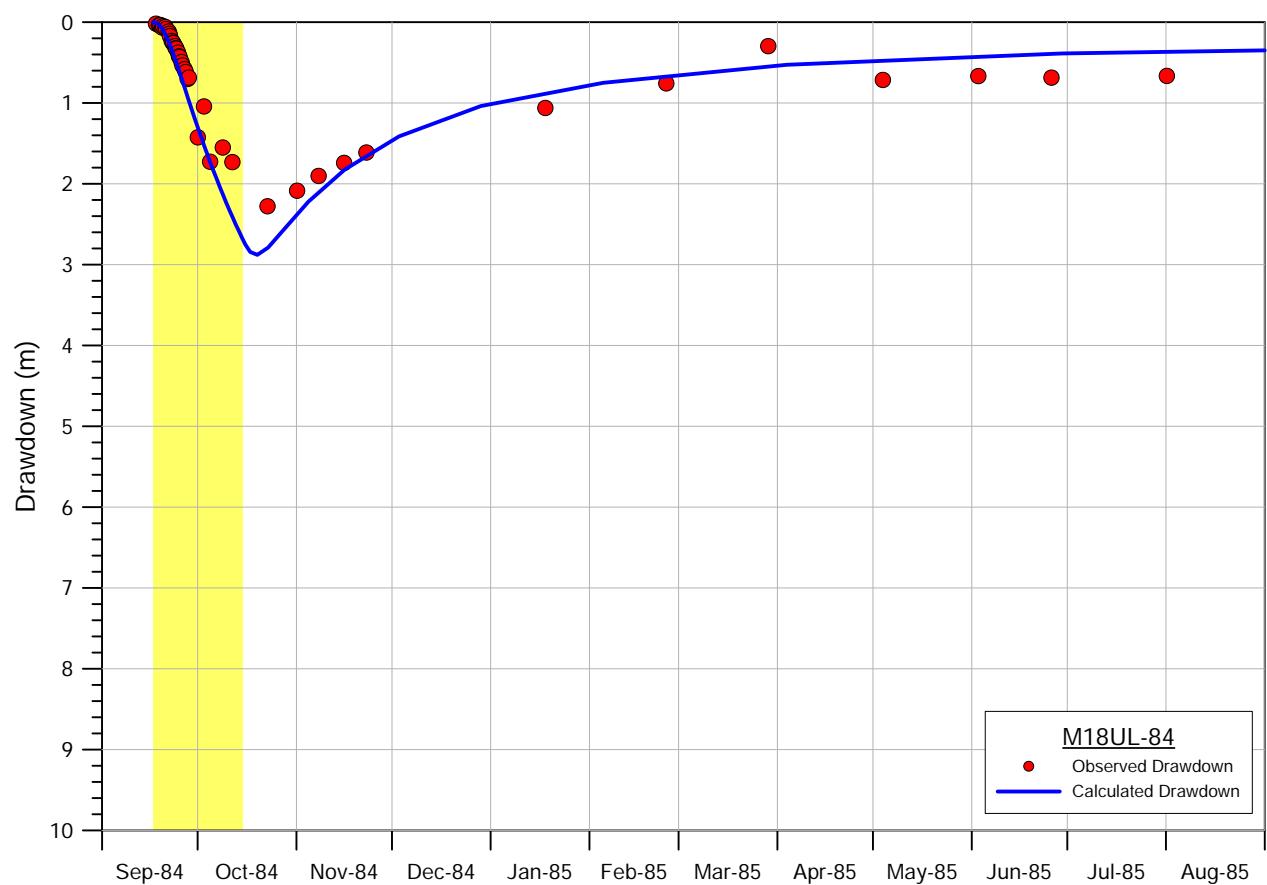
Figure D.6: Drawdown in wells **M20U-84** and **M18UL-84** during 1984 pumping test

Figure D.6: Drawdown in wells M20U-84 and M18UL-84 during 1984 pumping test
